**SOVIET TASK FORCE
HAVANA PORT FACILITIES , CUBA
23-07N 082-20W**

N-8457 NPIC (5/74)

SOVIET TASK FORCE
HAVANA PORT FACILITIES, CUBA

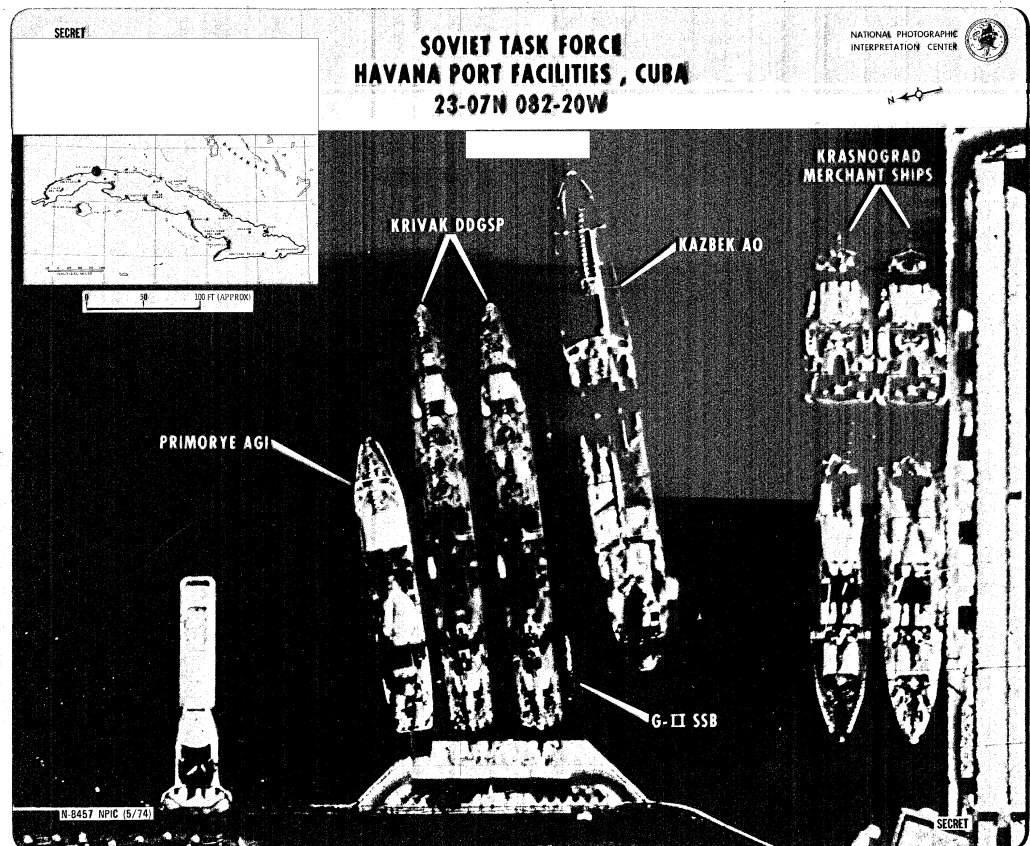
KRIVAK DDGSP

KAZBEK AO

KRASNOGRAD
MERCHANT SHIPS

PRIMORYE AGI

G-II SSB

A Soviet naval task force consisting of two KRIVAK DDGSP, one G-II SSB, one PRIMORYE AGI, and one KAZBEK AO were med-moored in Havana harbor. Two KRASNOGRAD merchant ships were berthed nearby in the harbor. This was the first identification of a KRIVAK DDGSP in Cuba.
